TECHNICAL REPORT
R-54

FACTORS THAT AFFECT OPERATIONAL RELIABILITY OF TURBOJET ENGINES

By LEWIS CENTER STAFF

1960

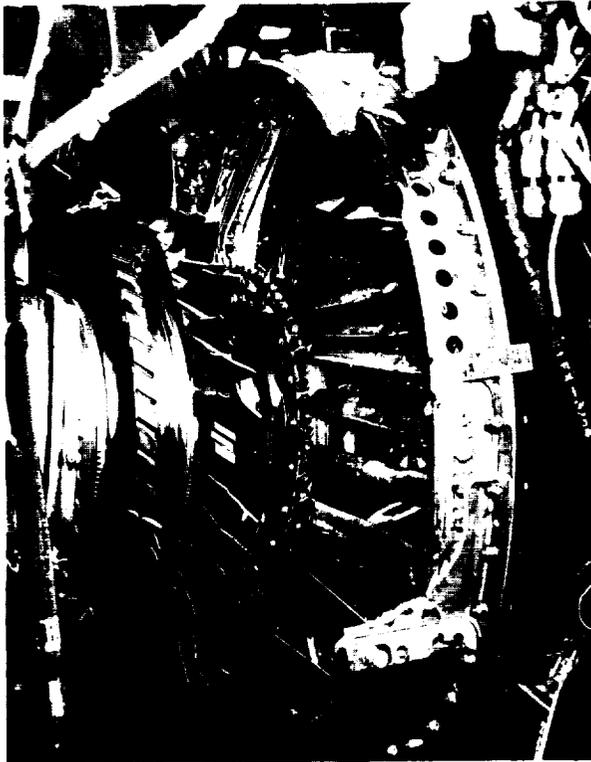
accumulated until it burst through the casing at the seventh stage. The damage resulting from a fatigue failure in a blade root is shown in figure 2. Six other blades in the same stage had extensive fatigue cracks in the roots and fractured upon impact. The remains of a more disastrous compressor failure are shown in figure 3. Part of the compressor went through the roof of the

FIGURE 2.—Damage resulting from fatigue of blade root in second rotor stage.

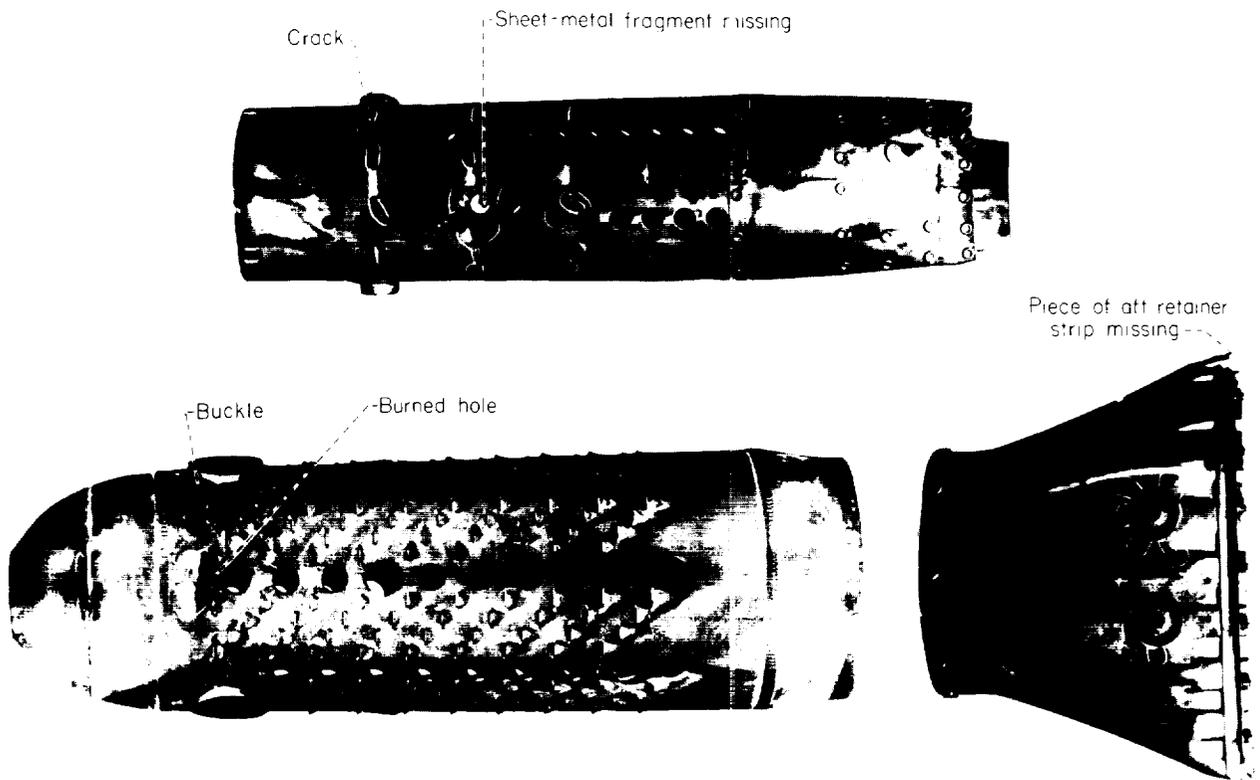
FIGURE 4.— Typical failures in turbojet liners.

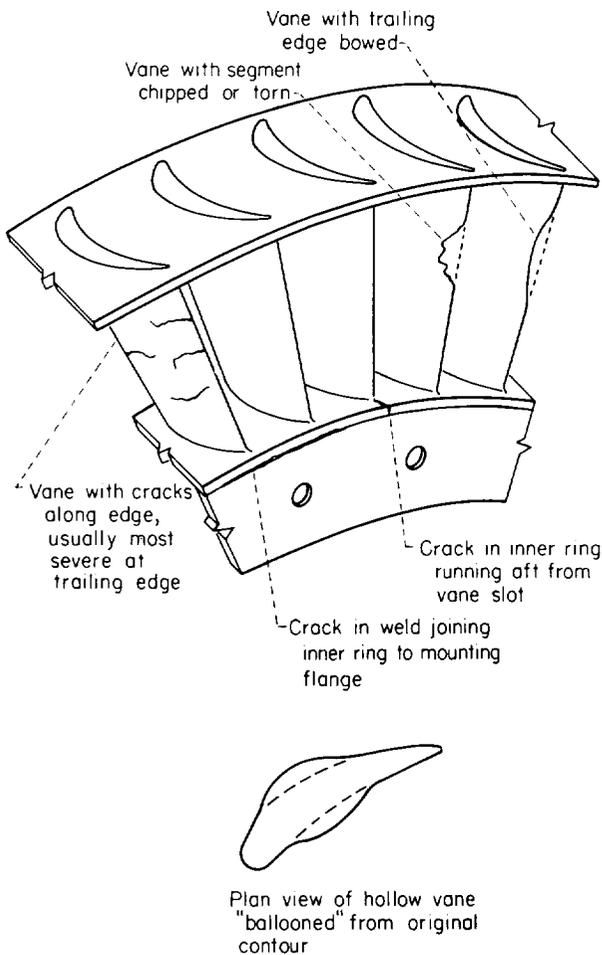
The most common type of damage was cracking of the nozzle vanes. Thus, for engine C-6, fully 92 percent of the engines overhauled (or every engine in which any damage to the nozzle

FIGURE 6.—Types of damage most common to nozzle diaphragms.

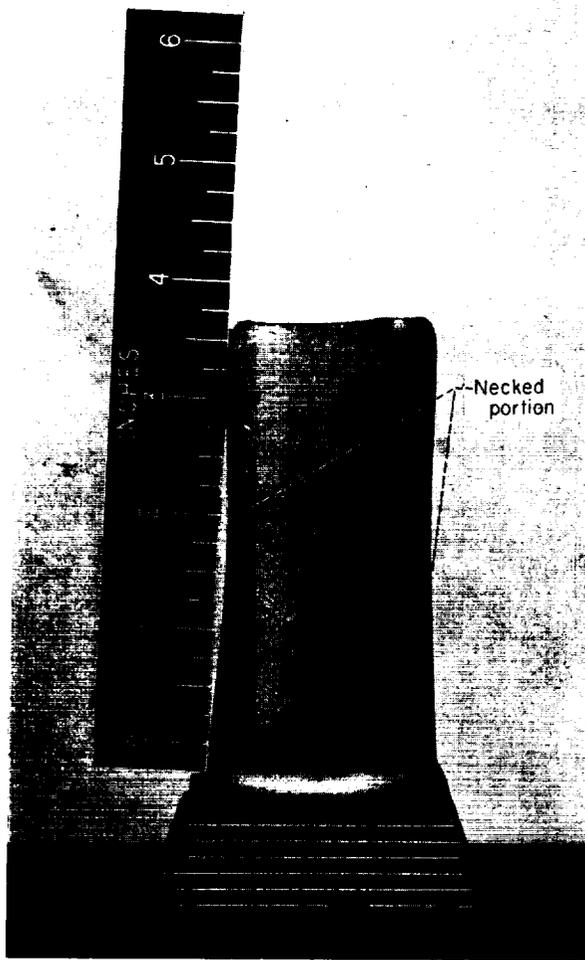
FIGURE 11.—Necked bucket.

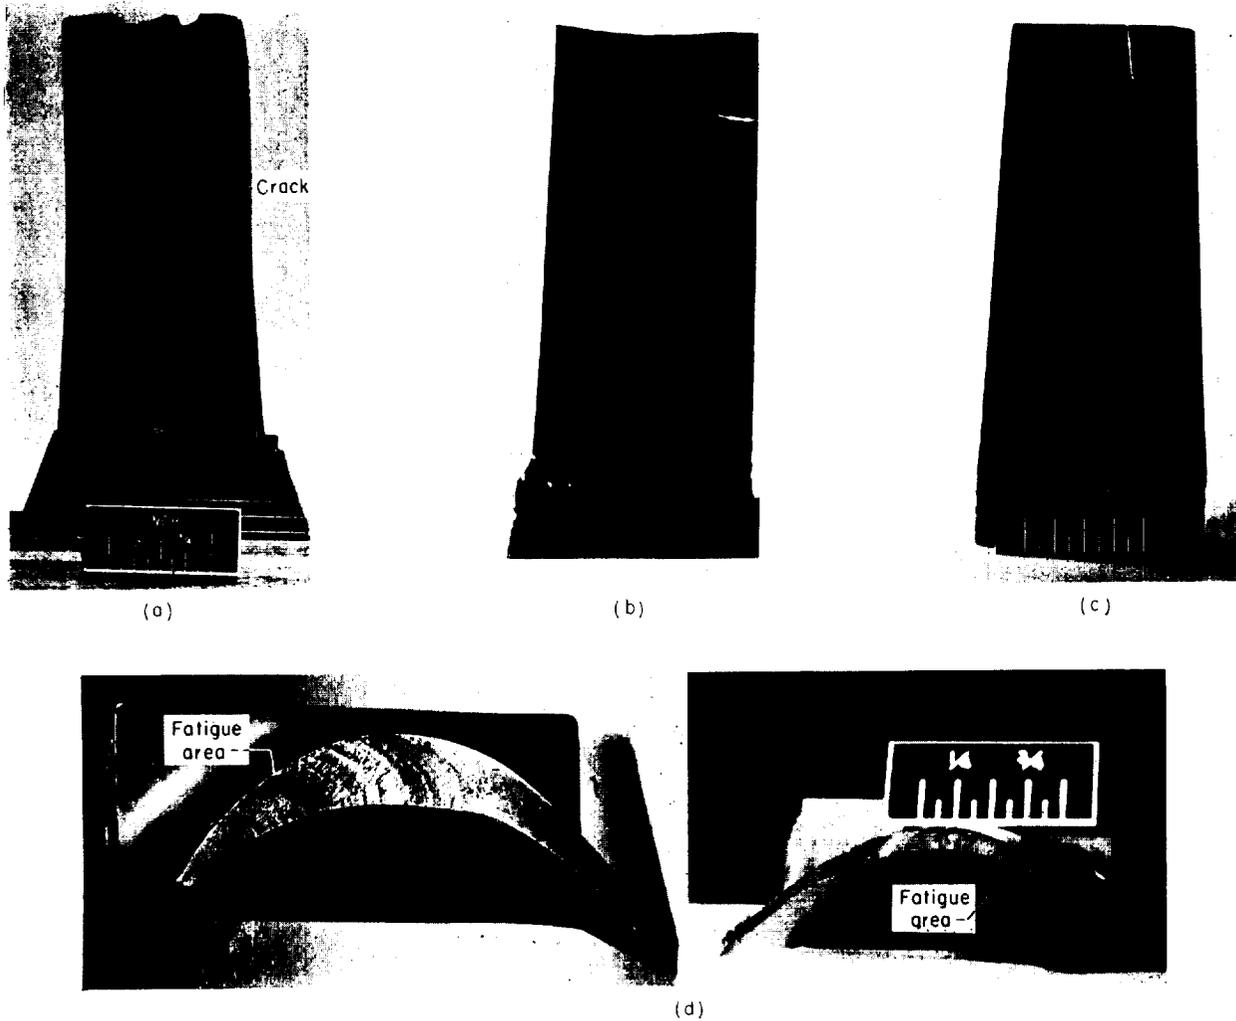
(a) Transverse cracks. (b) Transverse tip cracks. (c) Radial tip cracks. (d) Two typical surfaces.

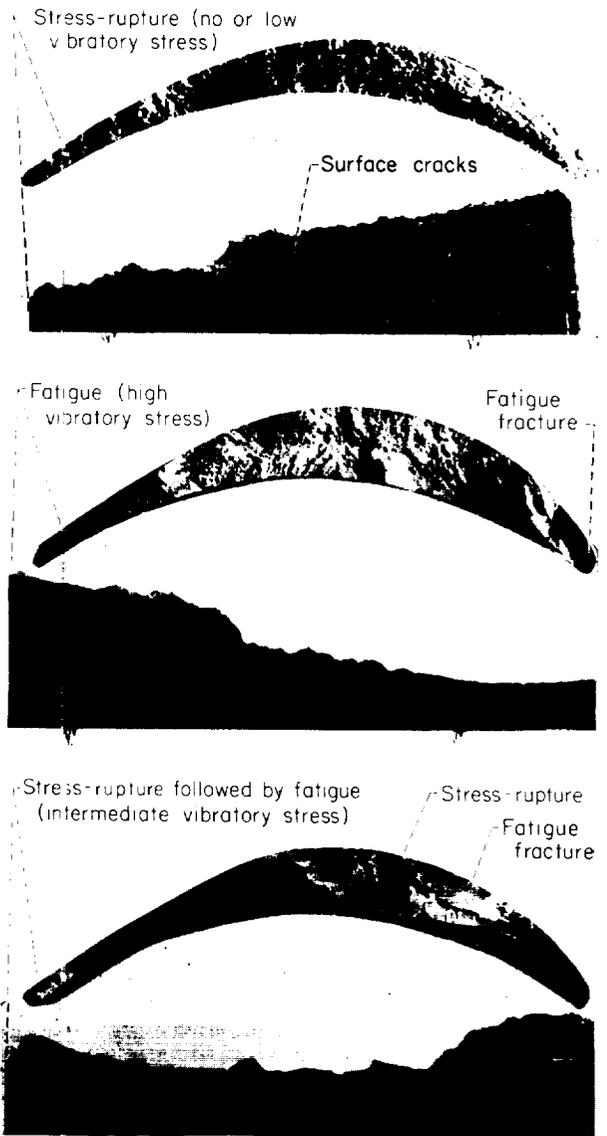
FIGURE 20.—Typical bucket failures.

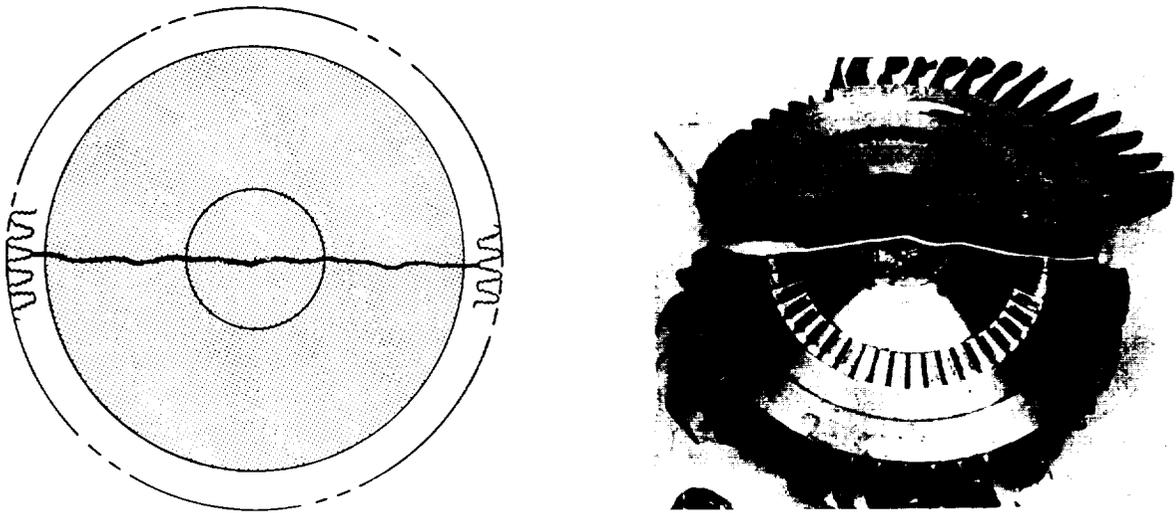
FIGURE 8.—Typical turbine-disk burst.

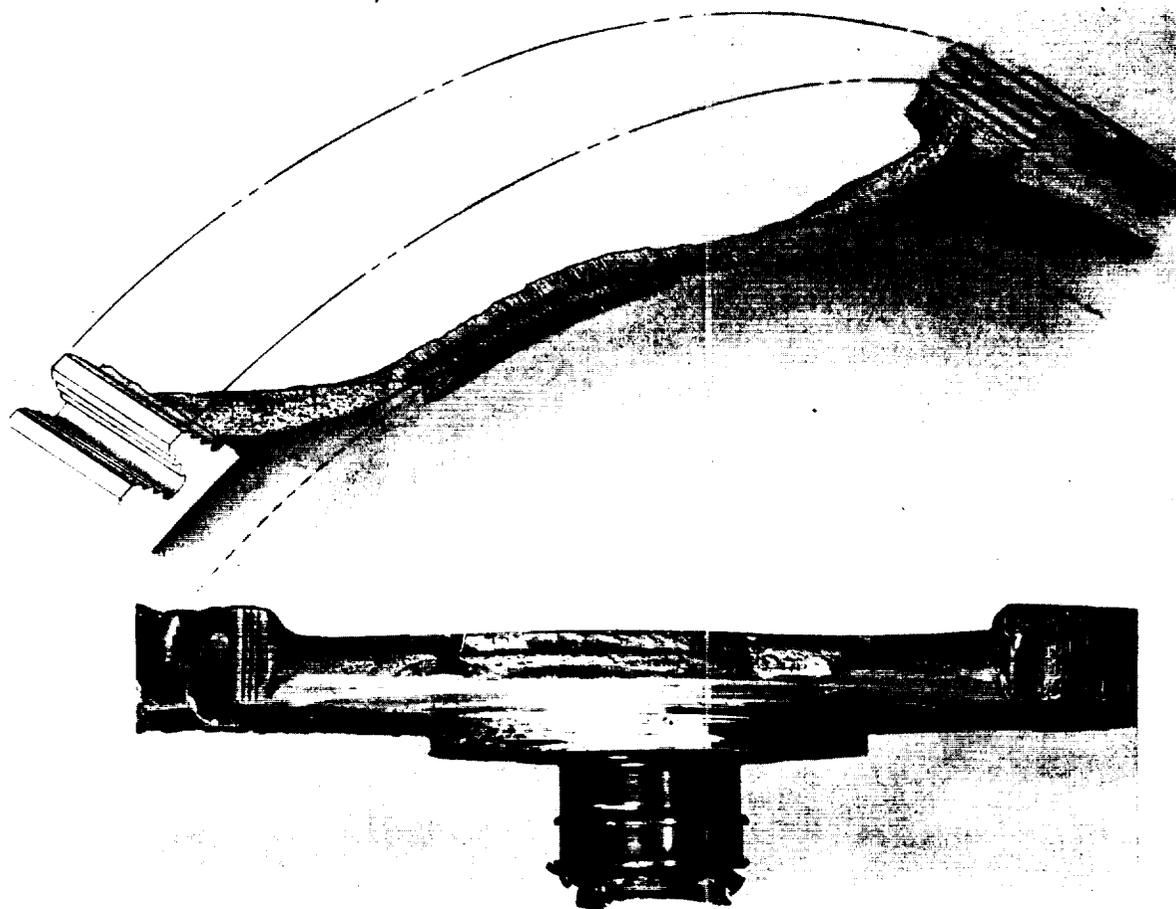
FIGURE 11. Weld failure.

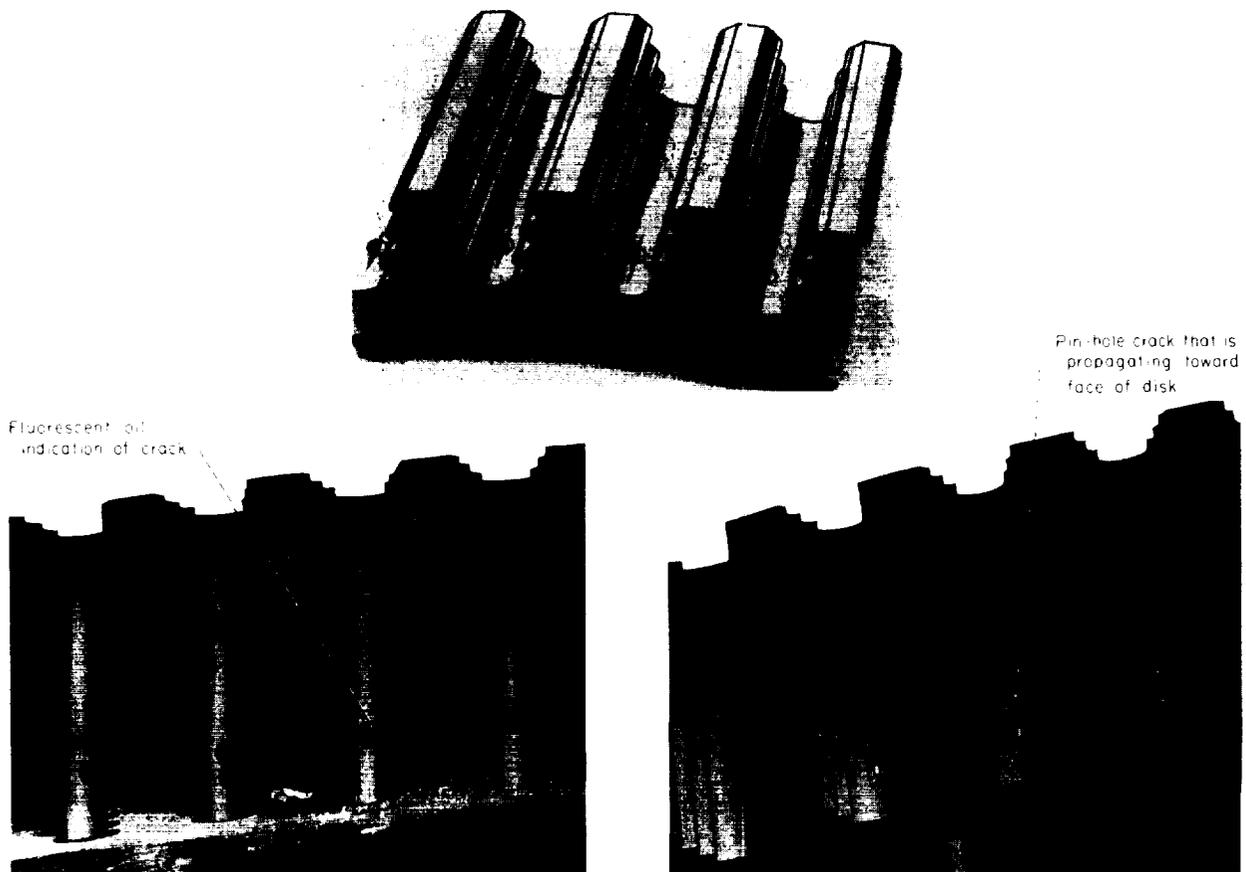
FIGURE 13. Pin-hole cracks.

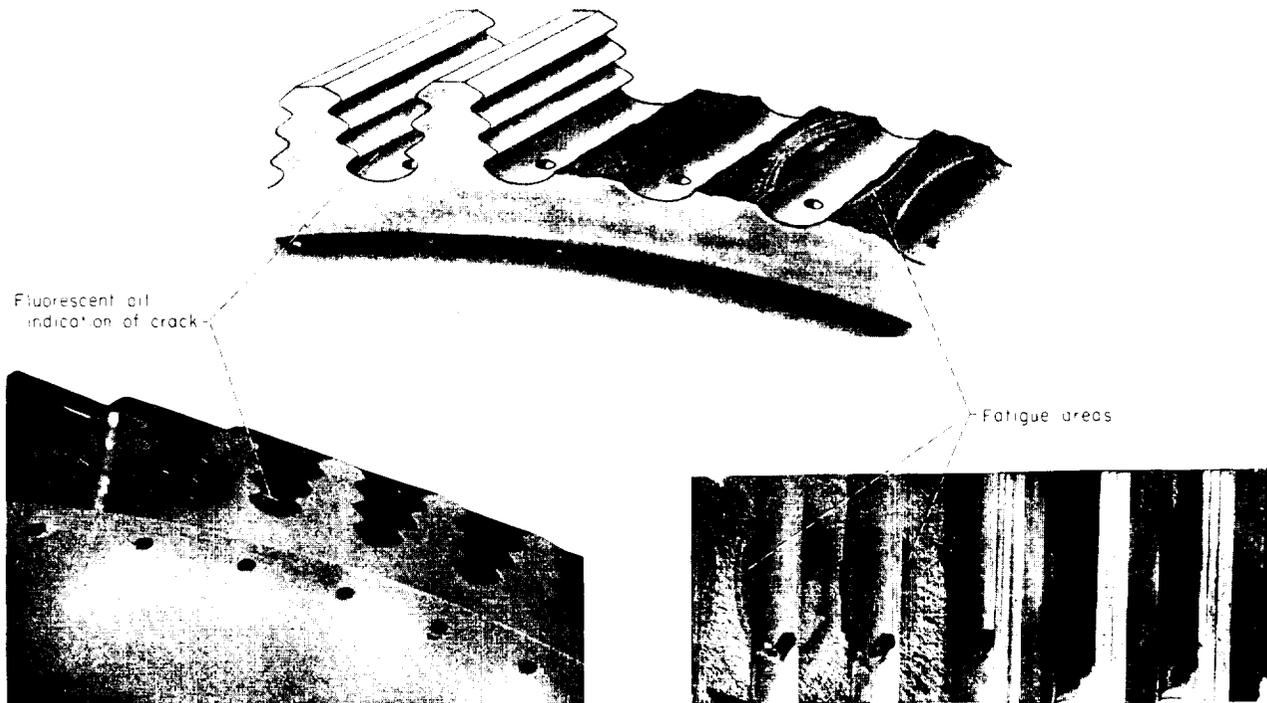
FIGURE 18. Serration failure.
